## Smoke and Dye-Water Observation Summary

### Western Run Pilot Project - Baltimore Maryland

## INSPECTION REPORT

STREET: ROCKWOOD AVE. 53 B 2	MAP #1: 2	MH: 1521918
CITY: BALTIMORE	MAP #2:	MH: 1521758
LOCALE: SMALL RESIDENTIAL STREET	TAPE #: JAM 2	TV'D LGTH: 15.8 ft

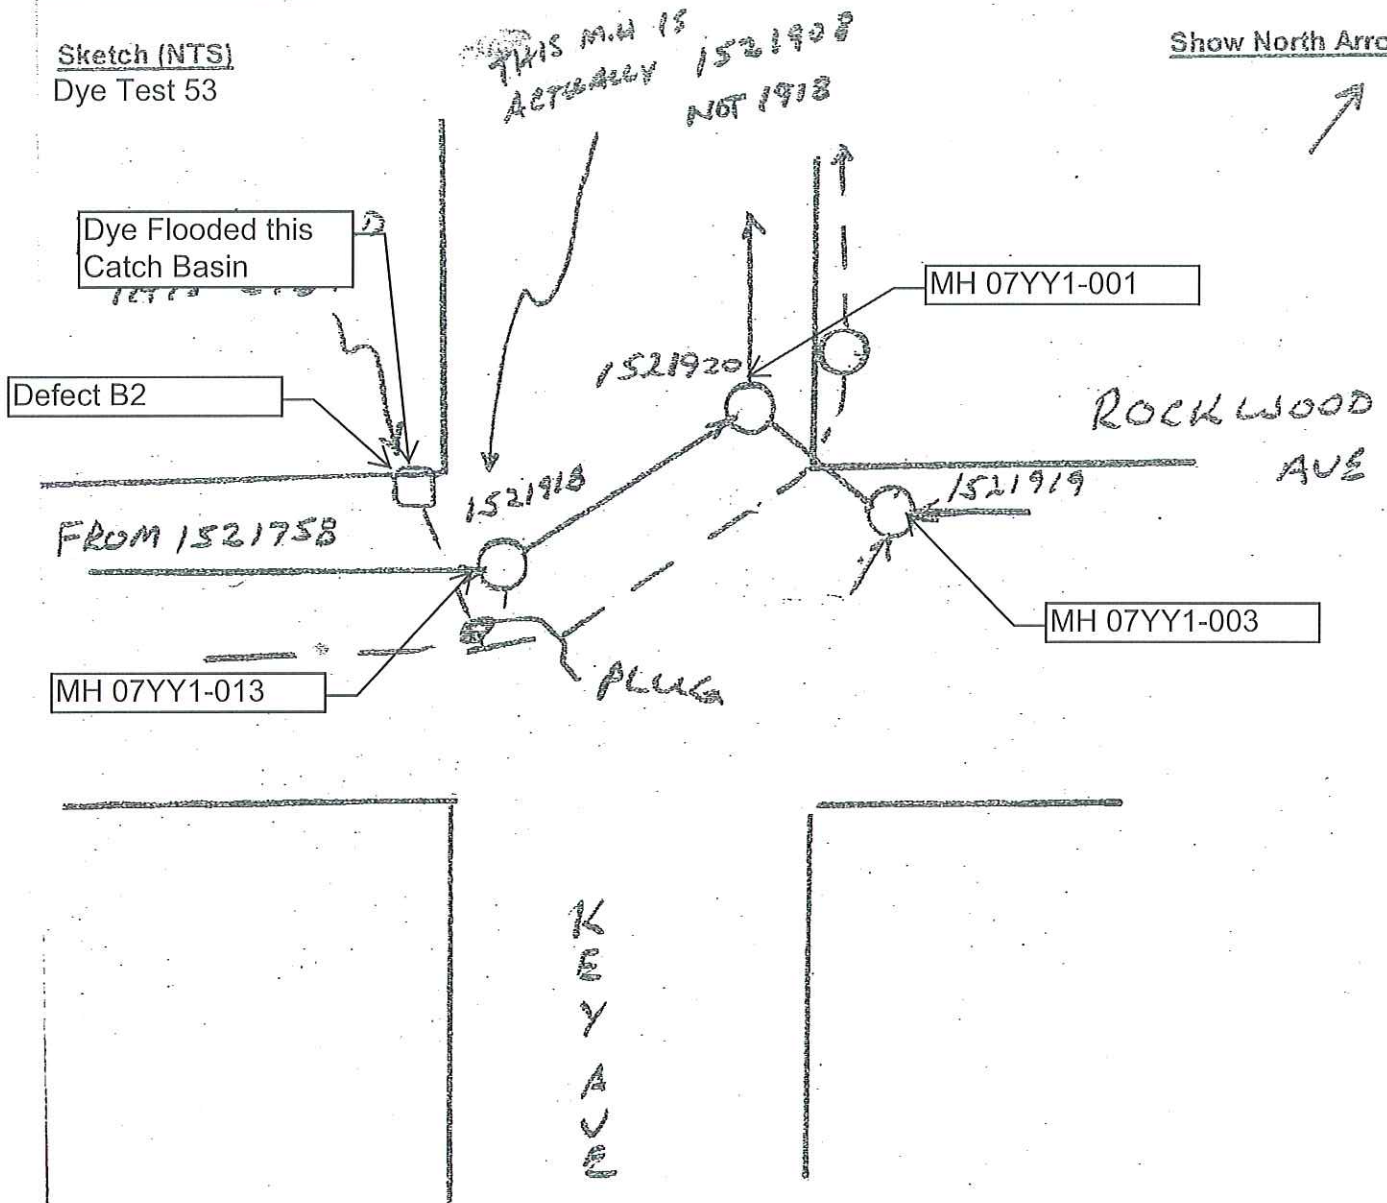
Sketch (NTS)  
Dye Test 53

Additional Comments: CAMERA WAS UNDER FLOW FOR MOST OF THE TIME, BUT COULD SEE JOINTS.  
KEPT M.H. #S CONSISTANT WITH SMOKE TEST SKETCH BUT SMOKE TEST SKETCH WAS WRONG.  
N.K.

REMARK: DYE TEST 53 B 2 /THE C.B. FLOODED WELL. RECEDED APROX. 3 GPM

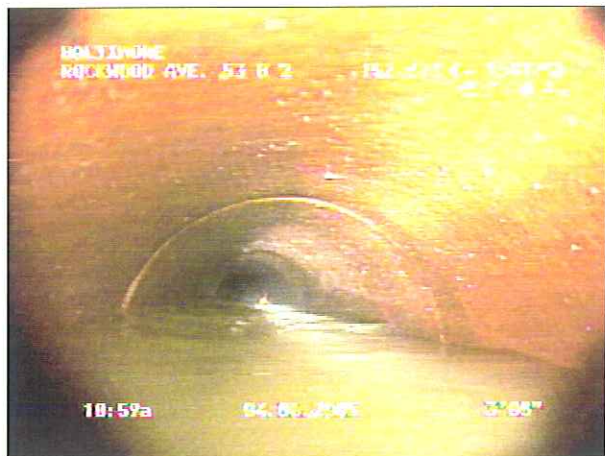
0.00	inspection begins at downstream manhole, 1521918 (1521908) ?		00:43:19	
	3.00	Infiltration Seeping at joint at 11 o'clock	2	00:49:34	46a
	15.80	inspection ends, CAMERA UNDER FLOW. NO MORE LEAKS SEEN AT JOINTS		00:49:34

IMAGE: 46a, TAPE #: JAM 2, 00:49:34  
3FT, Infiltration Seeping at joint at 11 o'clock
